A-108-S Trip Report

South Pole VLF Beacon and Receiver

Nov. 5 – Dec. 10, 2009

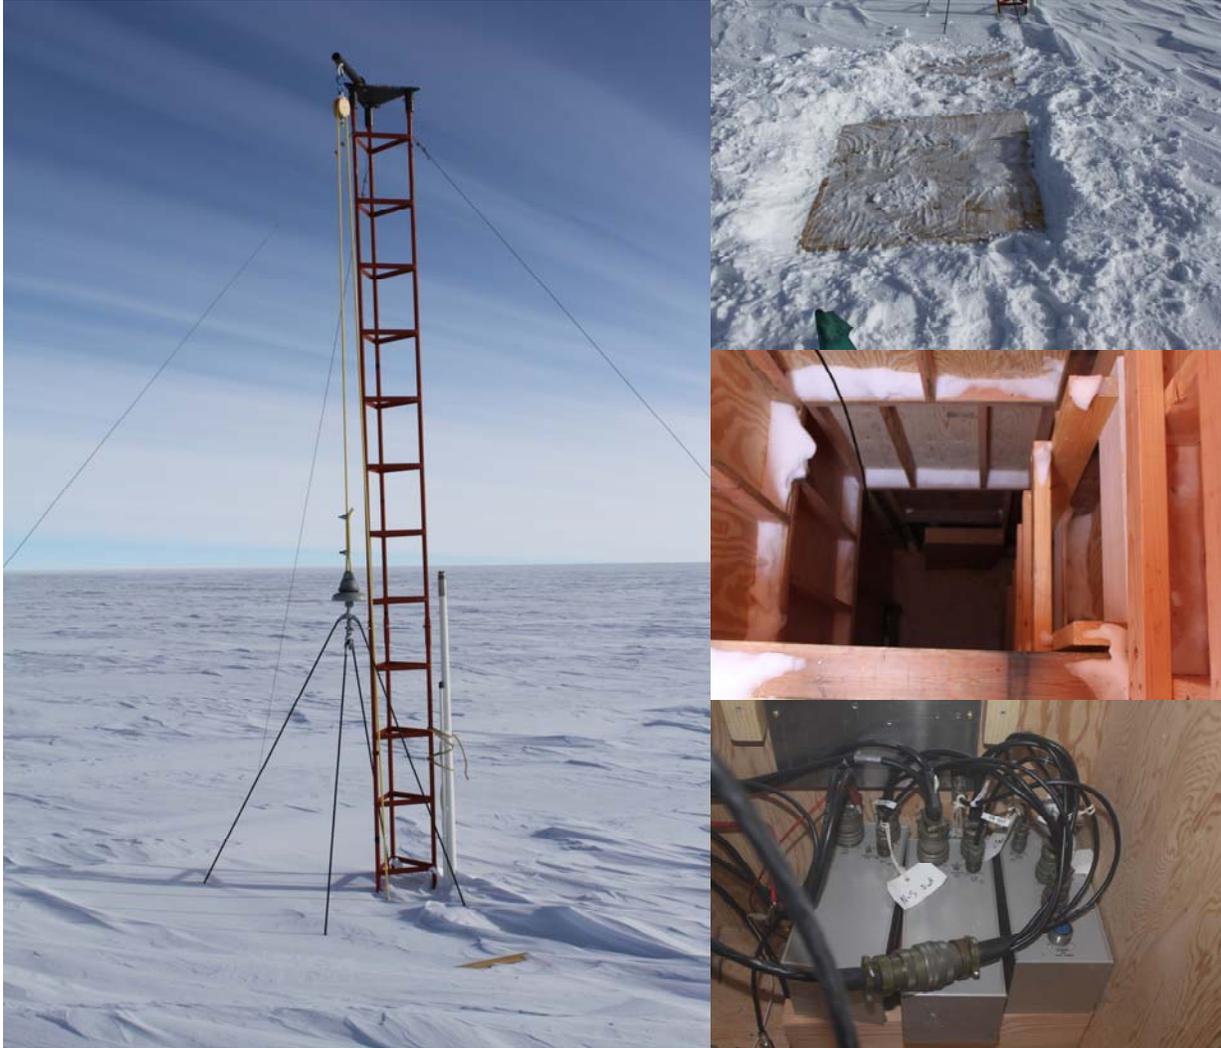
Figure 3: Clockwise from left: VLF antenna with only a few feet remaining above snow drift. Hatch of shaft was only under an inch of snow. The view from the landing down to the bottom. The preamplifier.

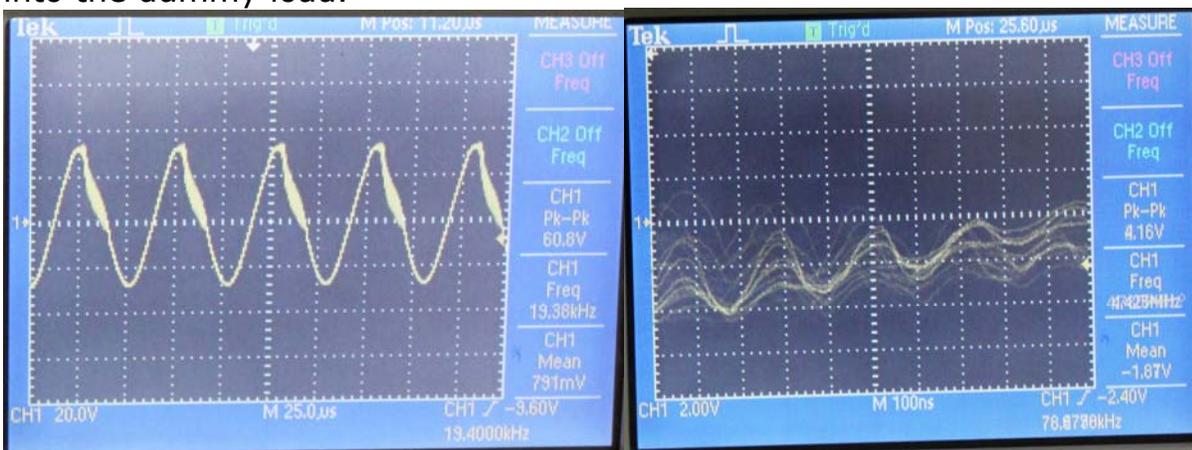
One final problem involved spurious oscillations near 4.5 MHz that are worse in some of the amplifiers than others. In all cases, they become insignificant near full power, but may be responsible for evidence of arcing when amplifier 5 is used with the antenna, although it does not cause problems into the dummy load.

Figure 8: Spurious oscillations deform the output of amplifier 5 (left). Triggering on spurious oscillations (right)

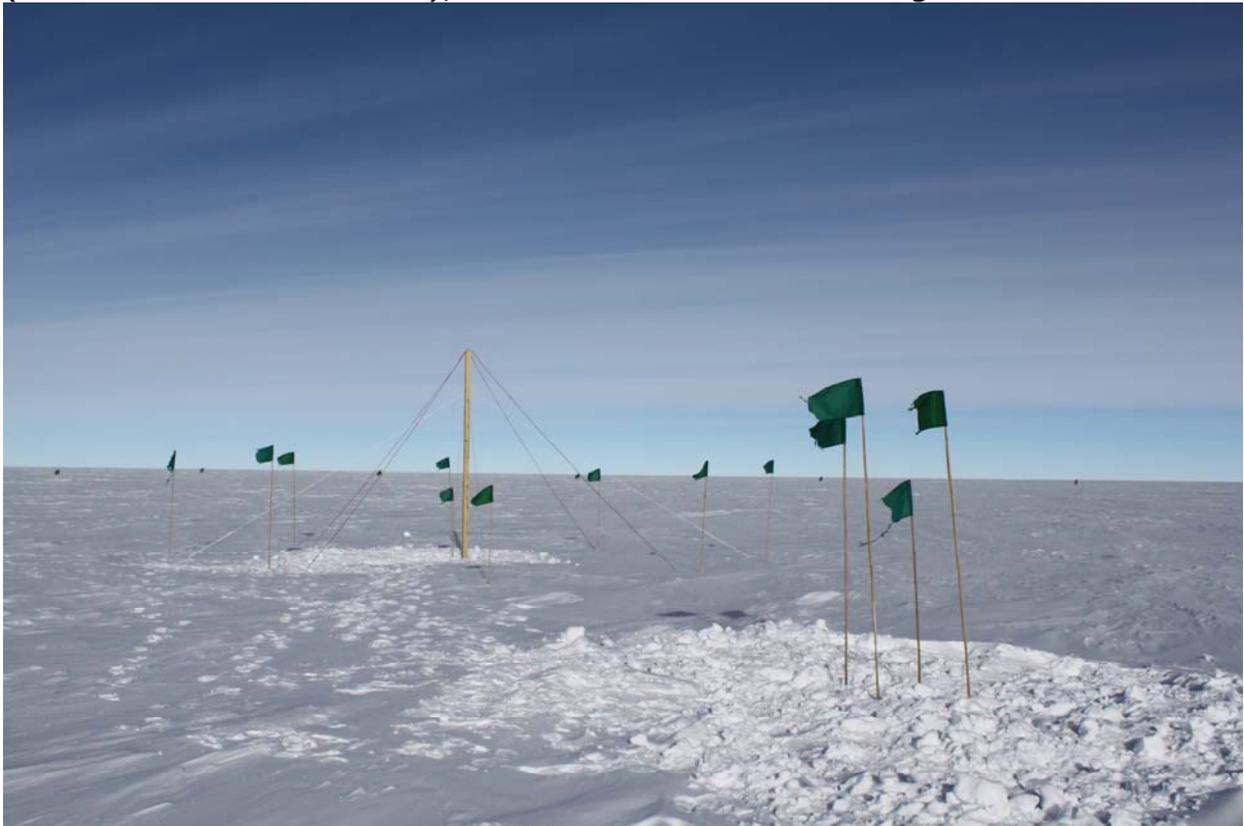
The PENGUIn low power receiver was located in the antenna field near the boundary with the clean air sector. The receiver was located near the antenna, marked with green flags, and a wooden post with the event number (A112) and a GPS antenna. The receiver was found buried under at least 6 feet of snow, protected by a piece of plywood. When recovered, the unit continued to record files until the unit was disconnected, although channel 1 did not appear connected after Apr 21, 2009 around 0705 UT, and files were only recorded sporadically after May. The batteries seemed to have power remaining. The voltage was measured at 6.96 V when cold (within hours of extraction), and 7.15 V the next morning.

Figure 10: PENGUIn antenna and excavation site for the preamp on the left, and the excavation point for the PENGUIn receiver on the right

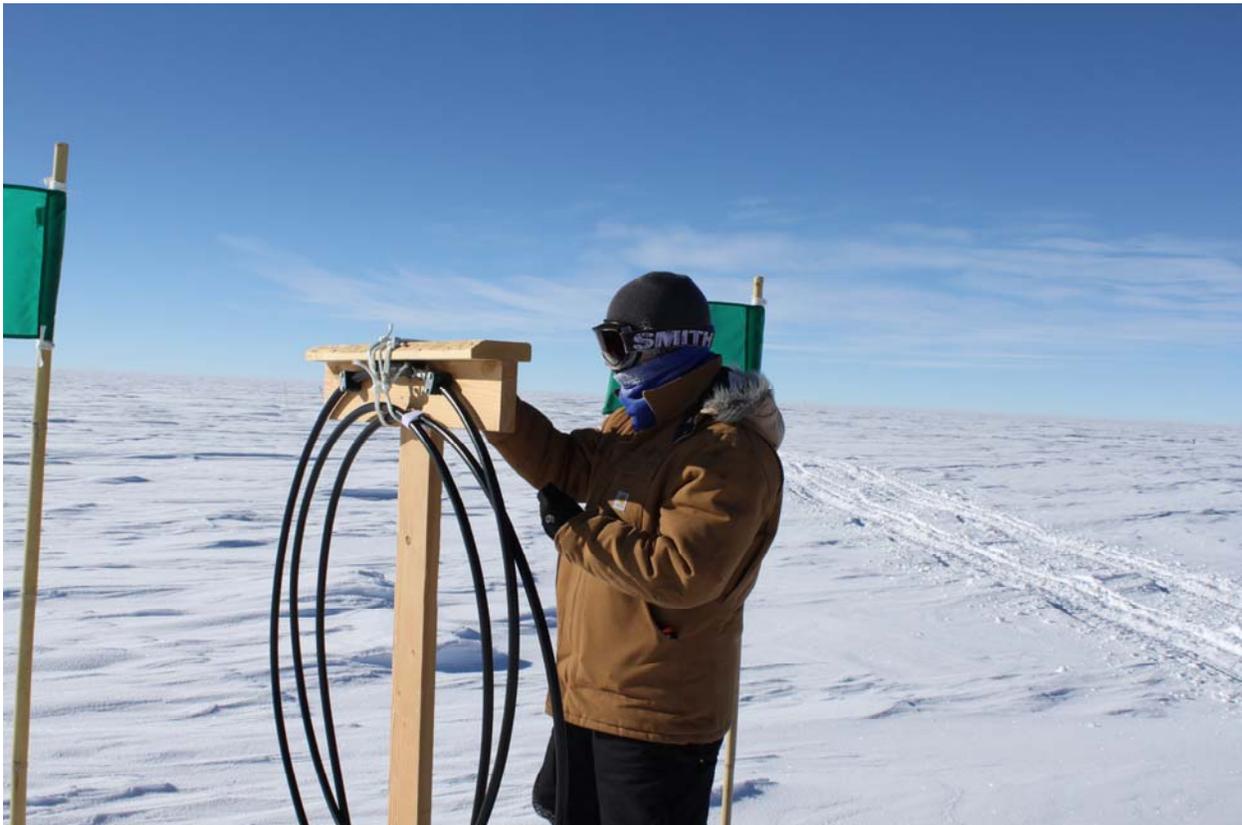
Figure 11: Ethan tightens some cable clamps at one of the transmission line junctions

The connectors on the LMR-900 transmission line at each of 8 junctions were changed from male N connectors joined by F-F barrels to male and female 7/16 DIN connectors, rated for higher power. The old connectors are sitting in the closet next to the VIPER control room. The N connectors and barrel adapters can be removed and used. The back nut should be the same for the N and 7/16 DIN connectors though it might be more difficult to remove from the cable.

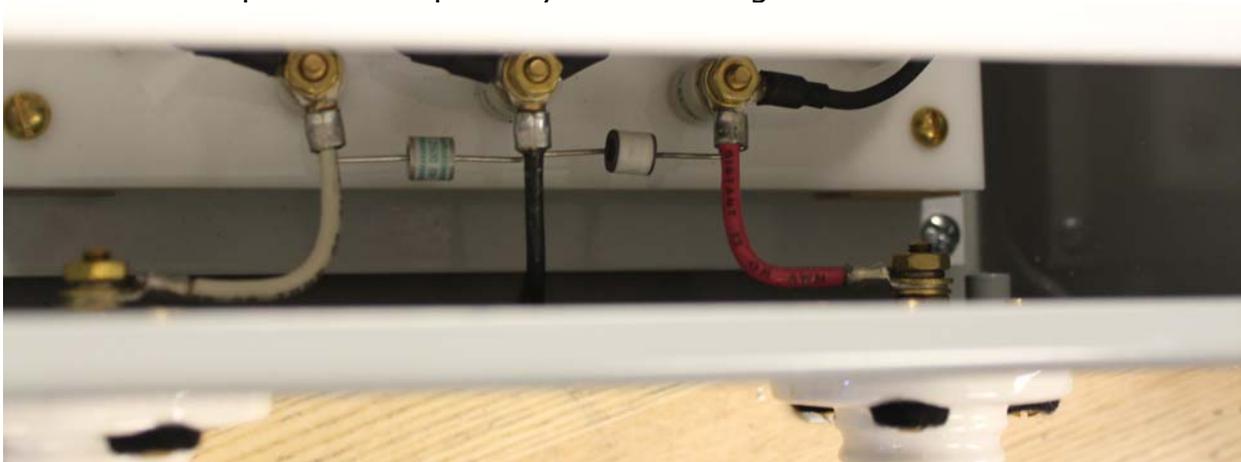
The surge protector attached to the grid south feed line was burnt when we arrived to take a closer look. It was replaced with the rebuilt transformer and the grid south end of the antenna was checked. No breaks were found. There were signs of arcing with gains above 700 and impedance mismatch at lower gains near 520. The new transformer was tested in the VIPER control room with the dummy load connected to the output with the good surge arrester. The setup oscillates strongly near 400 kHz with no input, but otherwise works with no arcing when the gain was increased to 1200. Finally the new transformer was swapped in again, using the still functional surge arresters from the old transformer. I probably lost the good surge arrester on the new transformer at this point. We also checked the grid north end of the antenna and found it to be free from breaks also. There were still signs of arcing at a gain near 200, but the impedance seemed correct at lower gains. We made an inspection of junction 4 on the transmission line, which the TDR indicated had slightly higher capacitance than the other junctions. The new transformer looked fine after a quick visual inspection. The same could not be said for the old transformer which had scorch marks on the side facing the input. Peeling back the tape revealed chunks of the ferrite core between the input ends of primary to be flaking off.

Figure 12: Failed surge arrester (right) versus what it should look like (left)

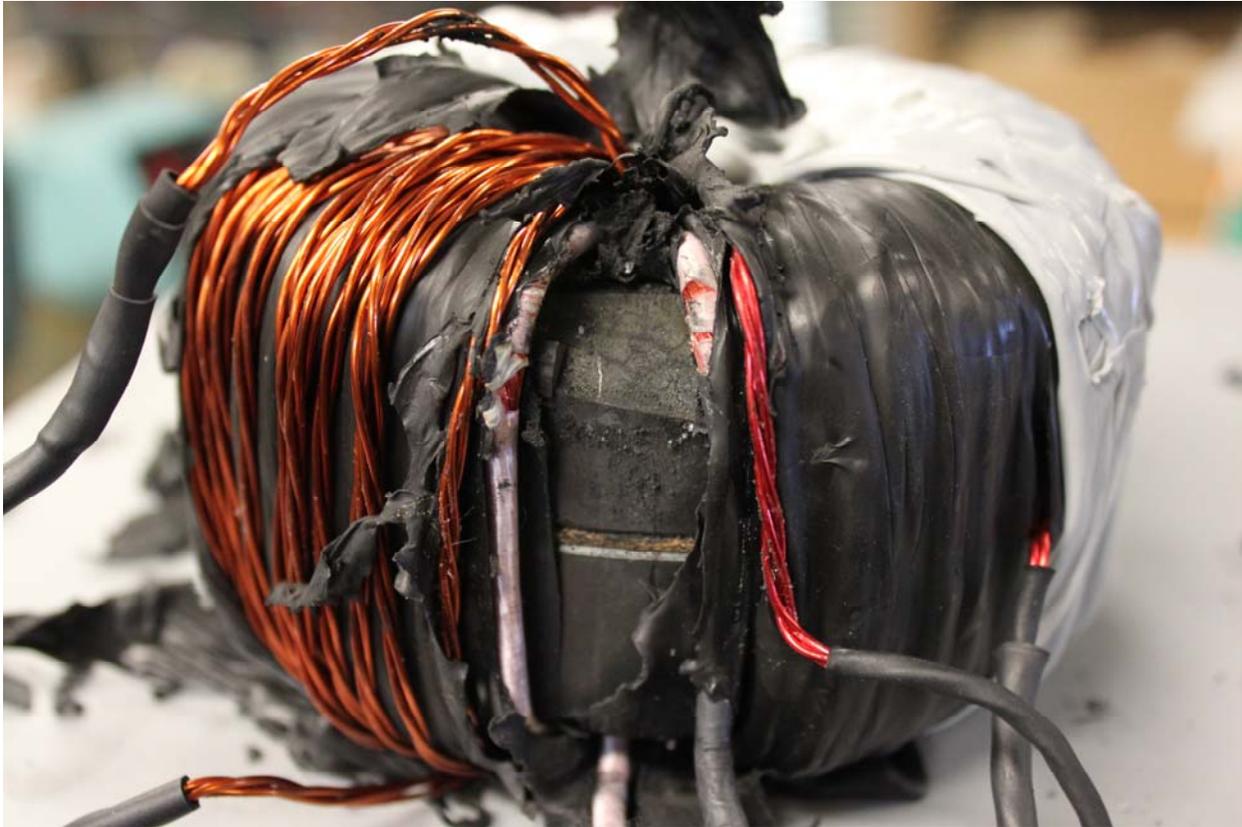
Figure 13: Extensive damage to the old antenna transformer

The male connector connected to the transformer was also replaced with its 7/16 DIN counterpart. Ethan and I then changed the transformer with the Mark II version, featuring surge arrestors and Litz wire. I also upgraded the old transformer with the surge arrestors a 7/16 DIN connector and new feed-through bushings to replace the cracked ones.
