A-108-S Trip Report

South Pole VLF Beacon and Receiver

Nov. 5 – Dec. 10, 2009

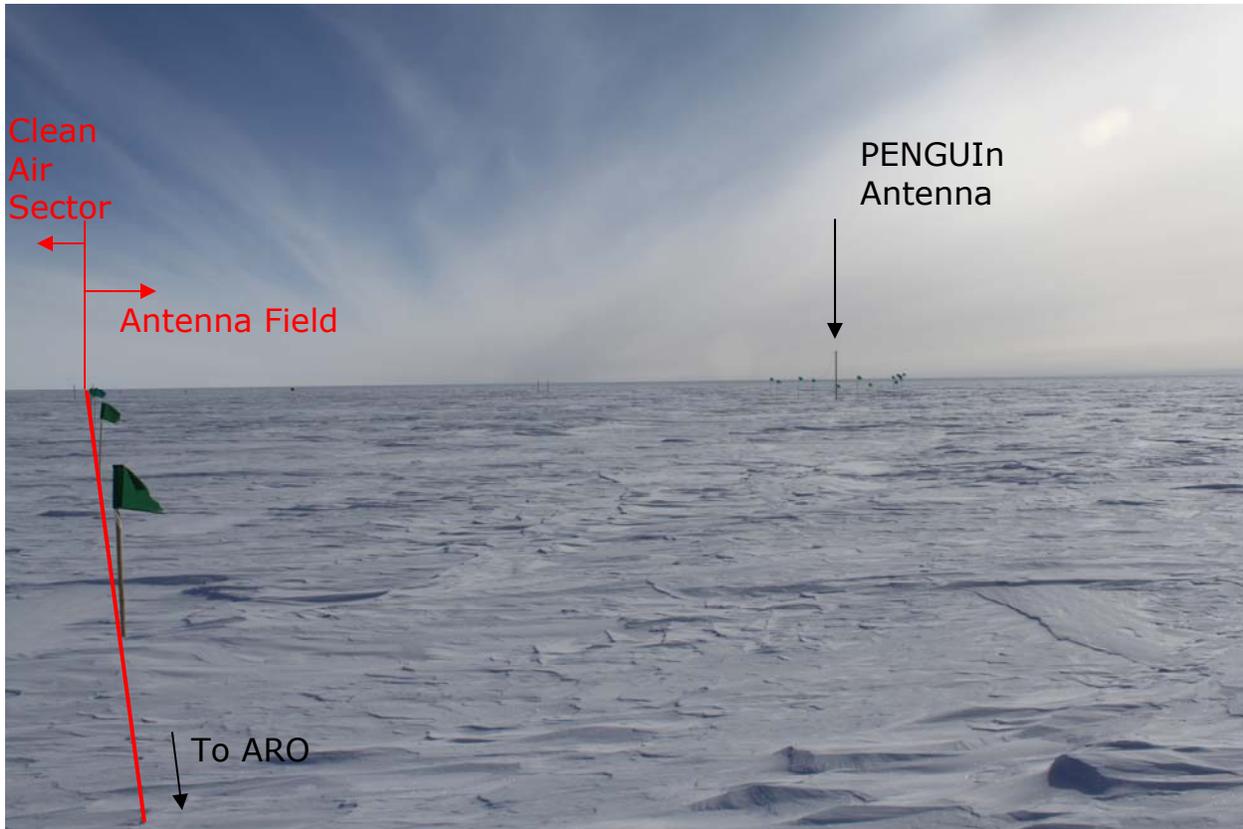
Figure 4: PENGUIn location

The PENGUIn low power receiver was located in the antenna field near the boundary with the clean air sector. The receiver was located near the antenna, marked with green flags, and a wooden post with the event number (A112) and a GPS antenna. The receiver was found buried under at least 6 feet of snow, protected by a piece of plywood. When recovered, the unit continued to record files until the unit was disconnected, although channel 1 did not appear connected after Apr 21, 2009 around 0705 UT, and files were only recorded sporadically after May. The batteries seemed to have power remaining. The voltage was measured at 6.96 V when cold (within hours of extraction), and 7.15 V the next morning.

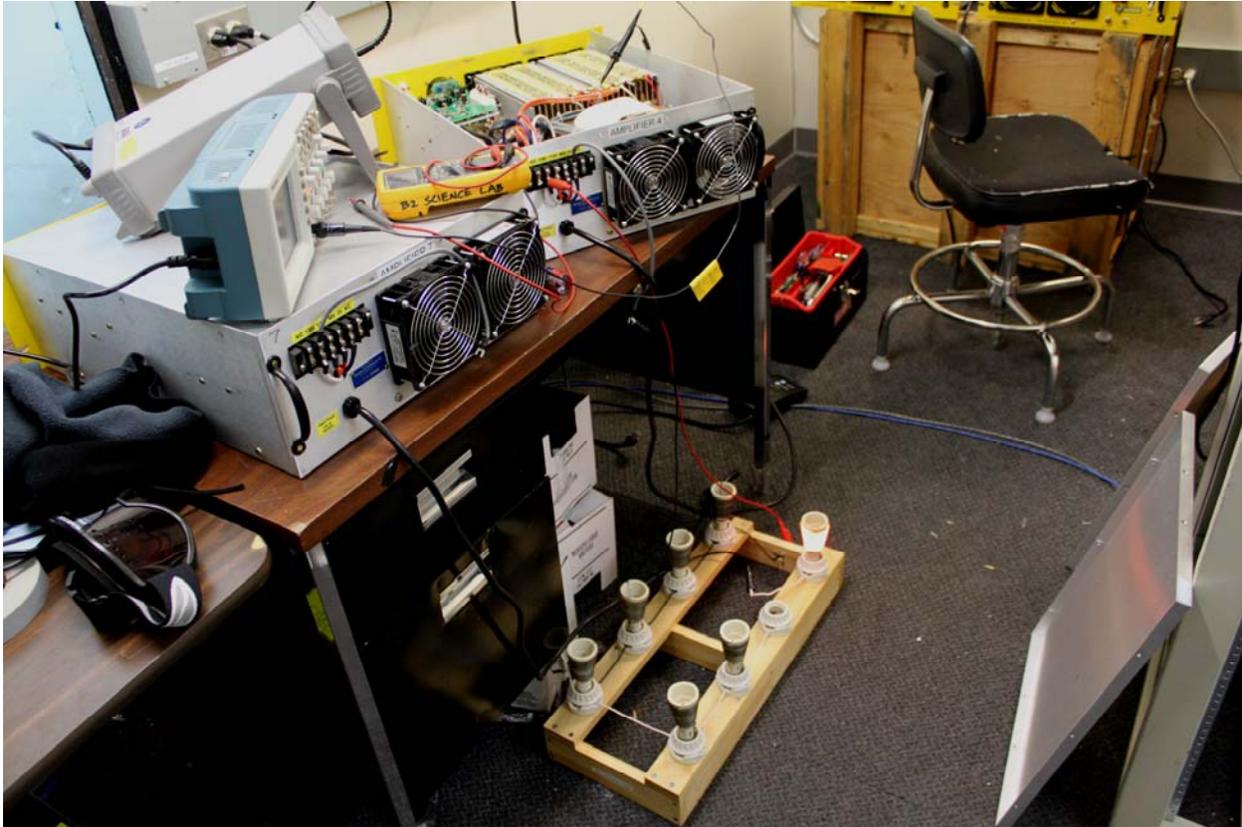
Figure 7: Amplifier test setup

Amplifier 5 had a drain voltage of only +32V as measured by the multimeter. Closer inspection using the oscilloscope on the output of the AC bridge, revealed very large ripple on the positive output rail indicating a faulty filter capacitor. There were two spares in the room, along with a few more with markings such as "Suspect" and "Beware of Terminals." Replacing

one fixed the + supply rail, but it was now slightly unbalanced with the negative rail (+51V vs -49V), so I replaced the other capacitor as well, since it also had a ripple of a few volts. Unfortunately I installed this capacitor backwards, causing the front breaker on the amplifier to trip from that capacitor shorting. Luckily it tested fine upon reinstallation and amplifier 5 performed similarly to the other amplifiers.

Debugging steps included removing capacitors to reduce spurious oscillations near 4.5 MHz and using a smaller capacitor to reduce the time-constant of the DC null offset circuit. The ultimate solution was to increase the size of the bootstrap capacitor. For testing, I modified two driver boards, installed them in two amplifiers and attempted to turn them on simultaneously with the inverters. The two amplifiers were connected in series to two dummy load elements and fed with the signal generator. Using 33 μF , 47 μF , and 66 μF in parallel with the existing 0.33 μF capacitor was insufficient. Adding a 500 μF (50V) capacitor in parallel with the 47 μF and 0.33 μF capacitors did work, and all the driver boards were modified with the 500 μF capacitor in parallel with the existing 0.33 μF capacitor.

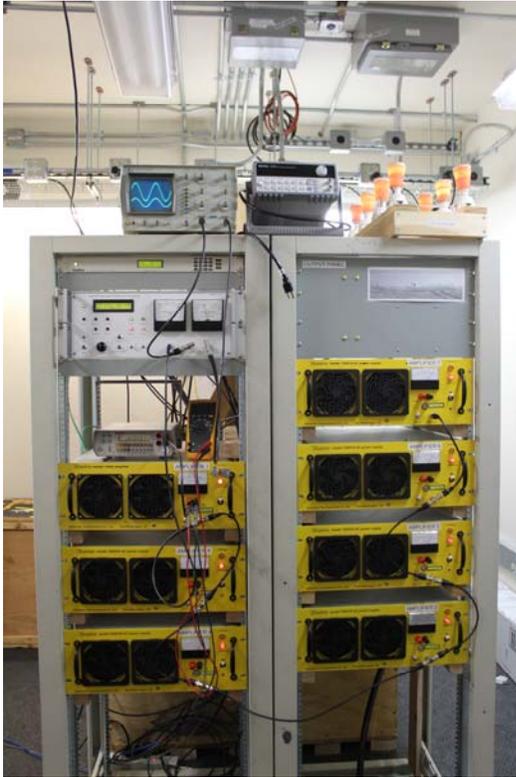
Figure 9: Testing 7 amplifiers into the dummy load

Ethan and I replaced the 7 amplifiers to the rack—they would not turn on. Turning on the inverters with all 7 amplifiers on creates a lot of noise from the inverters and high current draw (60 A according to the meters on the DC panel), but only the amplifier with an inverter to itself turned on. The amplifiers can be turned on one at a time by first turning on the inverters with the amplifiers off, then turning them on one by one, waiting a few seconds in between for the amplifiers to warm up. When tested into the dummy load, the amplifiers were found to work fine with a gain of 1300.
